RELATIONSHIPS BETWEEN BRAZING DEFECTS  
AND BRAZING CONDITIONS

David E. Schillinger

Frankford Arsenal  
Philadelphia, Pennsylvania

MEMORANDUM REPCRT M73-7-1

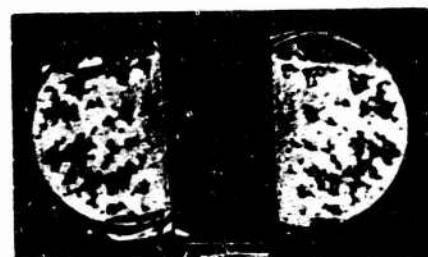
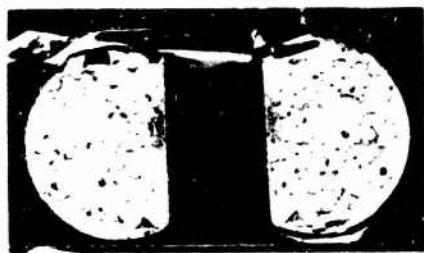
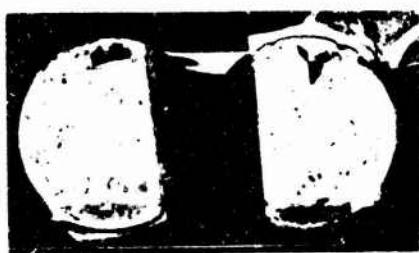
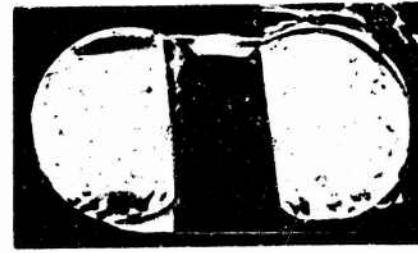
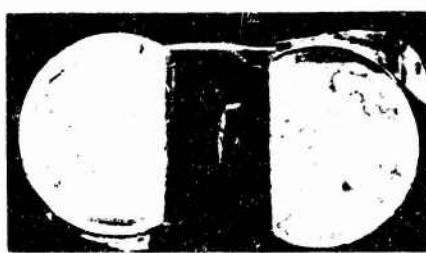
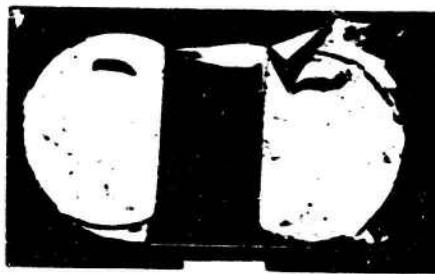
Figure 11. Results of Experiment 3 - Variations in Hold Time

Figure 11 shows the fracture surfaces of the specimens held for various lengths of time at the brazing temperature. It can be observed that this variable has no apparent effect, either positive or negative, on the number, size, or general character of the defects.

This experiment also provides an excellent display of the frequency and consistency with which defects appear in brazed joints of this type. In Figure 11, eight specimens are shown which have been brazed under ideal conditions by ordinary brazing standards, yet all of them have many large defects. The conclusion seems inescapable that, as currently prepared, the vast majority, if not all such joints are similarly defective.

3. Increasing time at brazing temperature has no beneficial effect with respect to defect formation in steels brazed with BAg-1 wire.
4. Introducing wire filler metal at brazing temperatures substantially above the melting point of the filler metal seems to reduce defect size and number, but further work should be done to verify this conclusion.

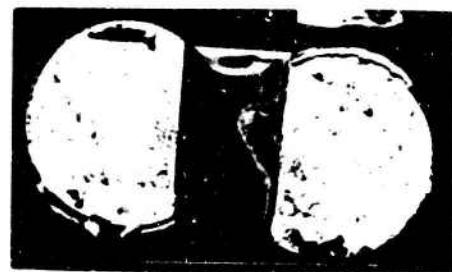
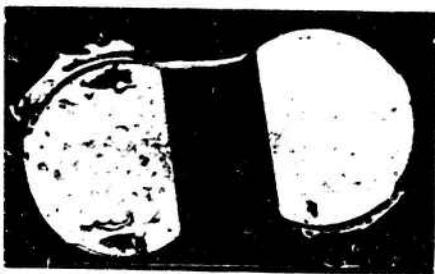
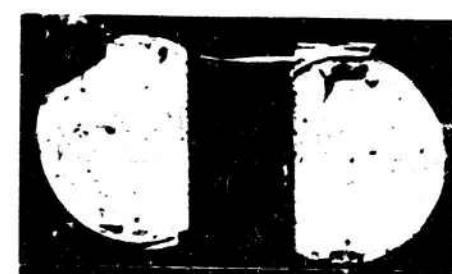
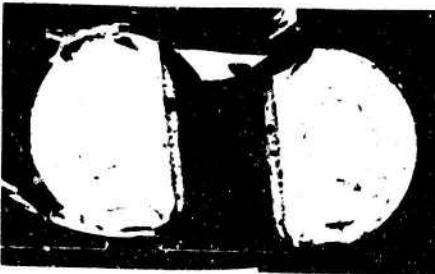
Figure 12 shows the fracture surfaces of the specimens produced in Experiment 4. In this series, there seemed to be a reasonably definite trend toward decreasing number and size of defects when the filler metal was introduced at higher temperatures. Specimen 4-F (filler introduced at 1400° F) is obviously better in quality than specimens 4-A and 4-B (filler introduced at 1200° F). Its mate, Specimen 4-E, except for the large defect in the center, also shows smaller and more regularly shaped defects.

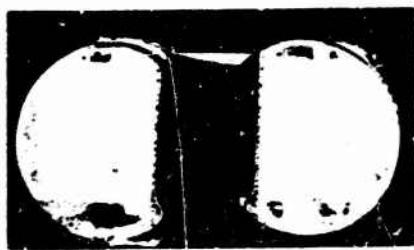
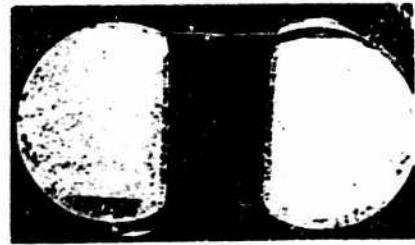
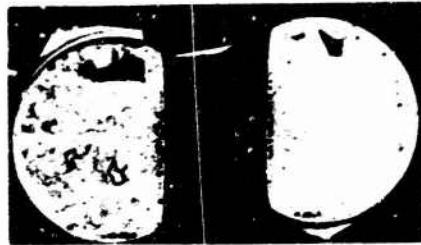
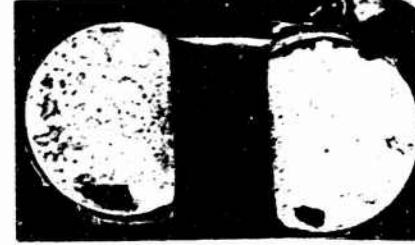
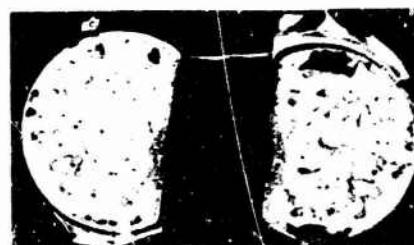
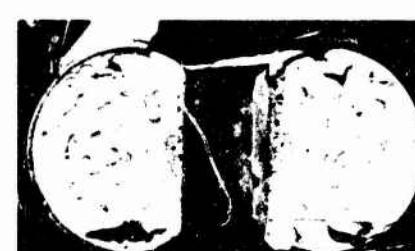
Figure 13. Results of Experiment 5 - Effects of Flow Opposed to Gravity

It may be seen by comparison of the various Figures that flow opposed to gravity does not produce great improvement with respect to defect formation. However, at the lesser clearances, (0.001 and 0.002 inch) the specimens in which filler flow was opposed to gravity do appear to be better with respect to the large defects formed along the outside of the flow path. For this reason it is probably desirable to employ flow opposed to gravity where it is feasible; however, it is obviously not a panacea for the problem of defects in brazed joints.

While it may not be obvious in the photographs, the broken specimens appear to be unbonded throughout a large area in the center, even though they also appear to be satisfactorily wetted in that area. It is not clear at this time why or how this happens, and further study will be required to determine with certainty what mechanisms are at work in this situation.

5. Filler metal capillary flow opposed to gravity is marginally helpful in reducing defects.
6. Reduced flow path widths are not helpful in reducing defects.

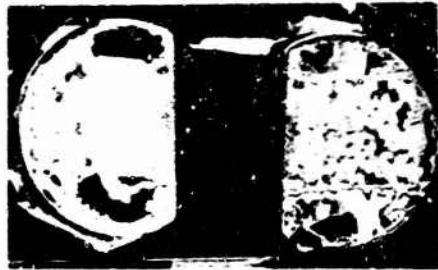
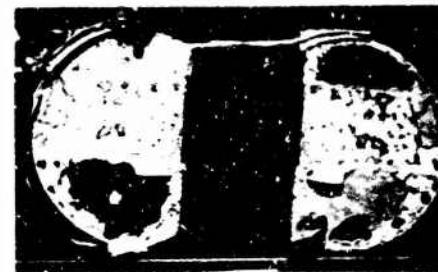
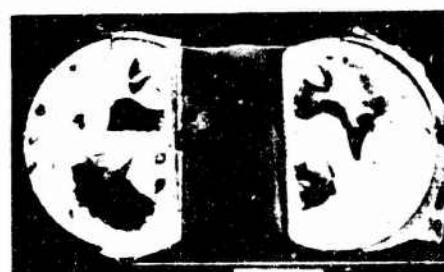
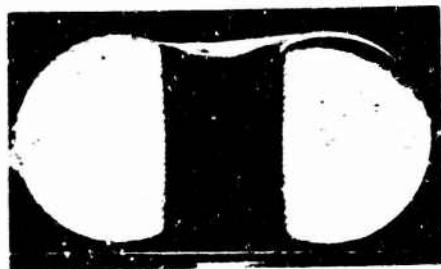
Figure 14. Results of Experiment 6 - Effect of Variation in Flow Path Width

Figure 14 shows the results of experimentation with flow path width. The specimens are shown in order of decreasing path width. The reasoning behind this experimentation was that if it could be shown that paths of restricted width produce less defects, then joints of larger area could perhaps be divided into many small paths by the inclusion of wire spacers or some other type of preform. However, as may be seen from the specimens, restriction of flow path width produced little or no benefits. Even the 0.06 inch wide paths have major defects directly through the center of the path.

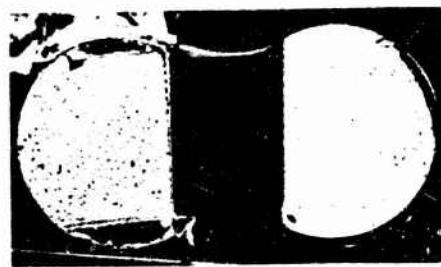
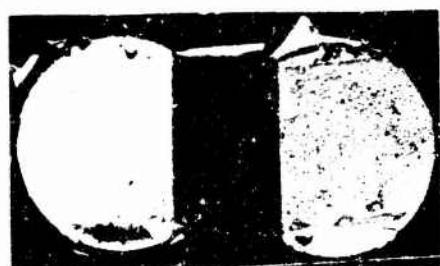
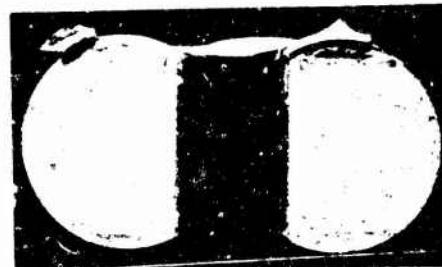
Figure 15 shows the results of experimentation with foil filler metals. Specimens 7-A and 7-B are the specimens which were made with 0.003-inch filler metal and no clearance spacer. It should be realized that in these specimens, after the filler metal melts, the spring-loaded brazing fixture automatically closes the gap to zero or near zero clearance.

Specimens 7-C and 7-D, 7-E and 7-F are specimens that were brazed with 0.003-inch foil filler metal and 0.003-inch and 0.002-inch steel clearance spacers, respectively. The general appearance of the fractured interfaces is about the same and it may be seen that, in general, the distribution, size, and regularity of the defects is considerably better than is generally observed in specimens made with filler wire.

7. The use of filler metals in foil form is very helpful in producing regularly distributed defects of small and uniform size.
8. Argon atmospheres are not significantly helpful in reducing defects when flux is used. However, brazing in argon without flux, while not completely practicable, produced nearly defect-free capillary flow in the one specimen for which it was tried.

It is recommended that foil filler metal be used in brazing steel, with BAg-1 filler metal, where feasible. This does not eliminate defects, but makes them individually smaller and more regular in character.

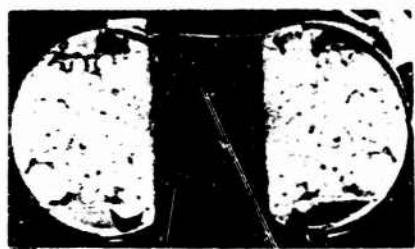
In Figure 16, the fracture surfaces of the specimens brazed in argon are shown. Specimens 8-A and 8-B are the specimens which were brazed with filler wire and flux in argon. These may be compared directly with specimens 2-G and 2-H of Figure 10, which were brazed under the same conditions except in air. It may be seen that there is little, if any, improvement. This observation tends to negate the theory expressed by Bredzs that defects are caused by oxygen diffusion through the flux and filler metal, with resultant formation of carbon monoxide bubbles at the steel interface. It also renders the dissolved hydrogen rationale unlikely.

Specimen 8-C is the specimen that was brazed in argon using filler wire, no flux, and a 0.003-inch clearance. This specimen was so poor in external appearance that only one specimen was made. The filler metal did not penetrate all the way through the joint and a large amount of it balled up in the "V" groove. However, when the specimen was broken, it was observed that the filler metal film which formed the brazed joint contained far less defects than any other specimen made in this study. While silver brazing in argon may not be a practical technique in most instances because of wetting difficulties, the specimen does strongly suggest that much of the difficulty encountered with defects is related to the flux-filler metal displacement mechanism.

Specimens 8-D through 8-G are the specimens brazed in argon with flux and 0.003-inch foil filler metal. No clearance spacer was used for specimens 8-D and 8-E, and the results obtained were very similar to those obtained in an air atmosphere where other conditions were the same (see Figure 15); i. e., a large portion in the center of the specimen was wetted but not bonded. The perimeters of the brazing interface were bonded but contained many small defects. Specimens 8-F and 8-G are the specimens made with foil filler and a 0.002-inch clearance spacer. Similar specimens were made in air (see Figure 15) and the results obtained in argon do not differ appreciably. However, as was previously observed, specimens made with foil fillers appear to be generally of better quality than those made by capillary flow of melted wires.
